# ANNUAL REPORT FOR 2009

**Unnamed Tributaries to Doby Creek Mitigation Site  
Mecklenburg County  
TIP No. I-3803A**

Prepared By:  
Natural Environment Unit & Roadside Environmental Unit  
North Carolina Department of Transportation  
October 2009

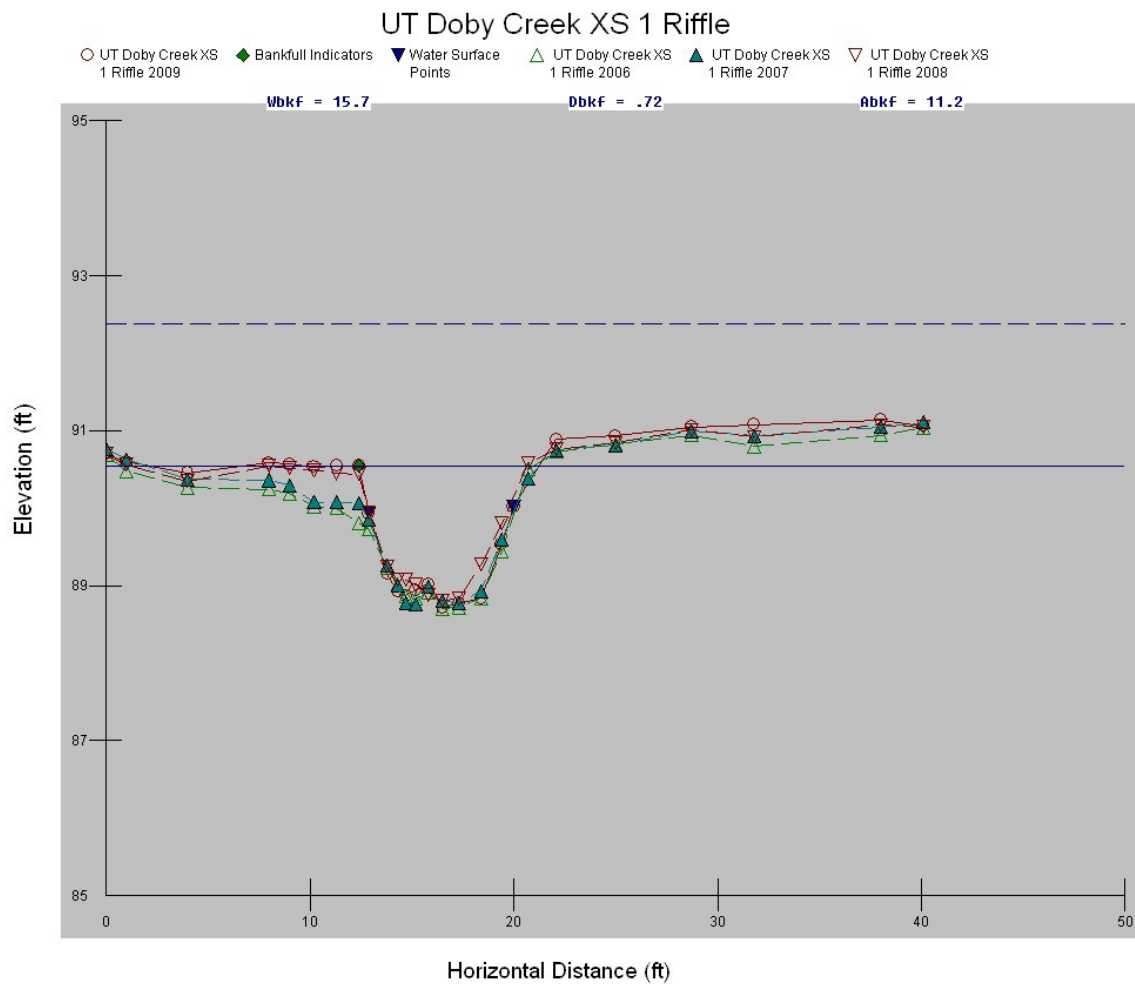
Based on comparisons of 2008 to 2009 monitoring data, both cross sections appear stable with little or no active bank erosion. It was noted on the graph for cross section #2 pool that some of the sediment deposited into the channel from last year has moved downstream. The beaver dam located downstream of photo point #3 has caused some aggradation along the lower end the stream restoration project. Debris deposited onto

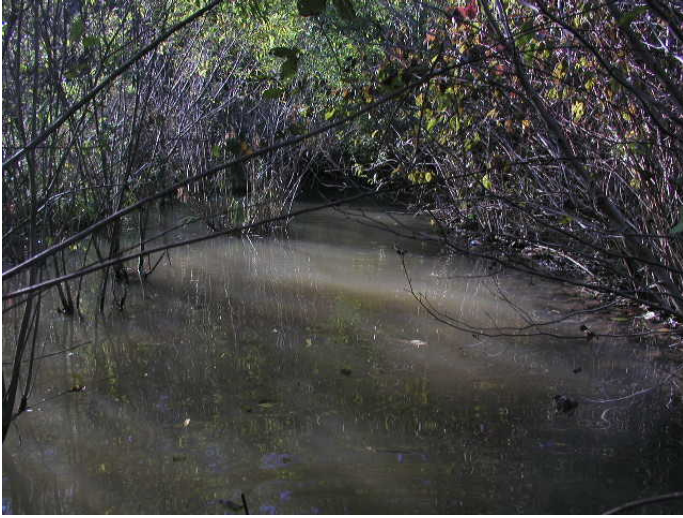
Photo Point #3 (Downstream)

A bank erodibility hazard index (BEHI) and near-bank shear stress (NBS) scores were not determined in 2009 because the longitudinal profile was not completed per the permit conditions (See Success Criteria Section 2.1). The longitudinal profile is needed to complete the BEHI and NBS scores. A longitudinal profile, BEHI, and NBS will be completed in 2010 by NCDOT. Overall, the channel was highly vegetated and very stable at the time of monitoring. A beaver dam located downstream of photo point #3 on the stream restoration project had approximately half of the site inundated with water.

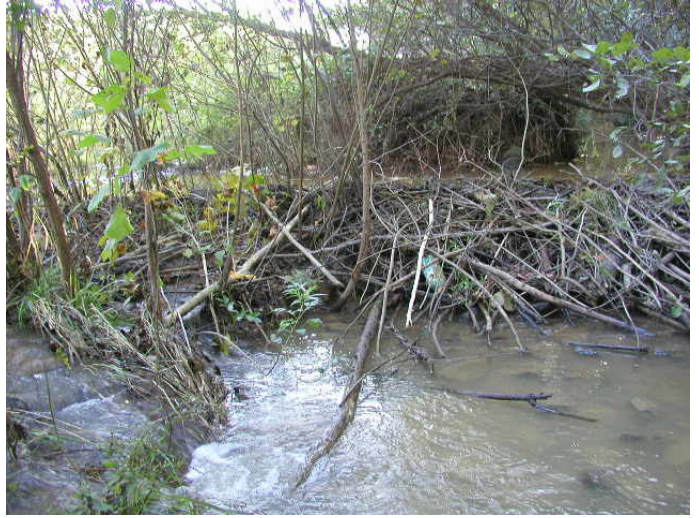
Based on the overall conclusions of monitoring along UT to Doby Creek, it has met the required monitoring protocols for the fourth formal year of monitoring. The channel is stable throughout the stream at this time, except for a beaver dam located downstream of photo point #3. NCDOT will contact the U.S. Department of Agriculture to remove the beavers and beaver dam from the site. The streambank and buffer area are highly vegetated for the fourth year of monitoring. The North Carolina Department of Transportation will continue stream monitoring at the UT to Doby Creek Mitigation Site for 2010.

Beaver dam located downstream of Photo Point #3

The UT to Doby Creek mitigation site has met the required monitoring protocols for the fourth formal year of monitoring. The channel and structures throughout the stream are stable at this time. NCDOT will contact the NCDA to remove the beavers and beaver dam located downstream of photo point #3 from the site. The streambank and buffer area are highly vegetated for the fourth year of monitoring. NCDOT will continue to monitor the UT to Doby Creek stream mitigation site in 2010.
